## ANALYSIS OF THE STABILITY OF THE KUBAN RIVER LANDSLIDE SLOPE INVOLVING THE MATERIALS OF LANDSLIDE HAZARD MONITORING

M.A. Bandurin, V.A. Volosukhin, I.A. Prikhodko, A.A. Rudenko

Kuban State Agrarian University named after I.T. Trubilin, Krasnodar, Russian Federation

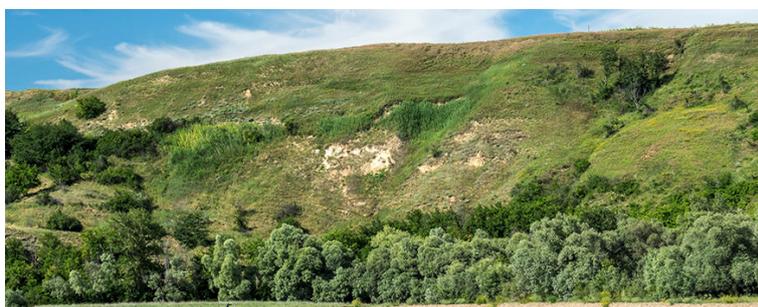
Fig. 1. Washing out sandy soil at the base of the slope  
Рис. 1. Подмыв песчаного грунта у основания склона

At the research site to study engineering and geological conditions based on materials from studies of previous years (2017) [15–16], 4 profiles were passed: 3 profiles along the slope (perpendicular to the coastline), one profile along the coastline. Distance between profiles 125–700 m. Taking into account the detailed study of the area under consideration three years ago, in addition to verifying the reliability of the surveys of previous years, it is planned to drill the V section, consisting of 4 wells with a depth of 4.5 to 8.0 m with a distance between workings from 10 to 12 m, while reducing the distance between workings in sections IV-IV, along the bank of the Kuban River, from 125–700 to 125–400 m (Fig. 1).

During a route survey of sections of the right bank within the urban development of the city of Armavir, Krasnodar Krai, located close to the edge of a steep slope, it has been observed an intensification of erosion processes which progresses every year. The main residential development is located from 5 to 15 m from the edge of the slope. It is almost impossible to get there by transport due to the fear of a landslide. The slope is steep up to  $45^\circ$ , littered and in some places reinforced with available materials: slate, tires, boards, etc.

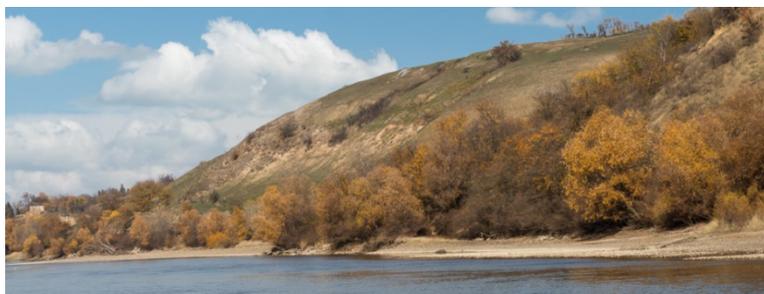
Fig. 2. View of the Kuban River in the alignment of the landslide slope  
Рис. 2. Вид на реку Кубань в створе оползневого склона

Fig. 2 shows a recorded landslide with a separation wall of 1.5–2.0 m from sandy soils, which came down along with the trees, 270 m to the south along the stream, in a section of 100 m. Currently it is observed the remains of trees with uprooted roots. The sliding plane for landslides is gray-green, hard loam. Groundwater in the area under consideration lies at a depth of 13–13.5 m and is discharged into the river Kuban. In some areas, they are observed to come to the surface near the water's line.

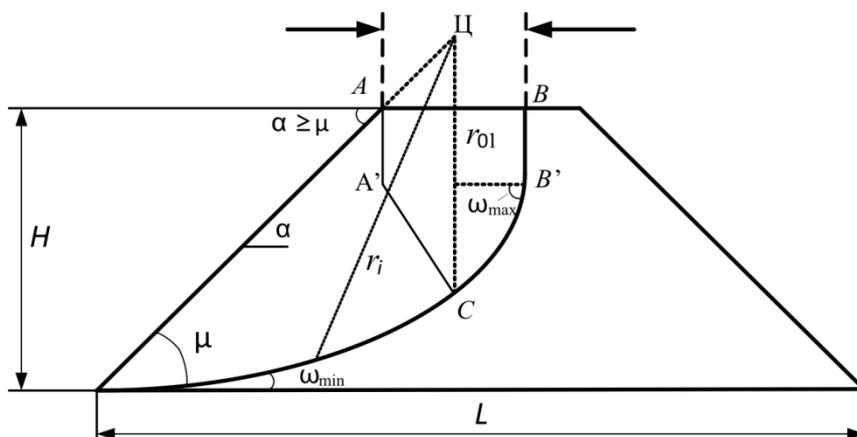
Fig. 3. Scheme of the formation of a landslide in a slope  
 Рис. 3. Схема формирования оползня в откосе

Let us perform a stability calculation taking into account seismic loads, since  $\mu = \frac{\pi}{4} - \frac{\varphi}{2} = 29^\circ$ , then the stability calculation is carried out according to the scheme in Fig. 3.

The sliding surface is constructed in the following order:

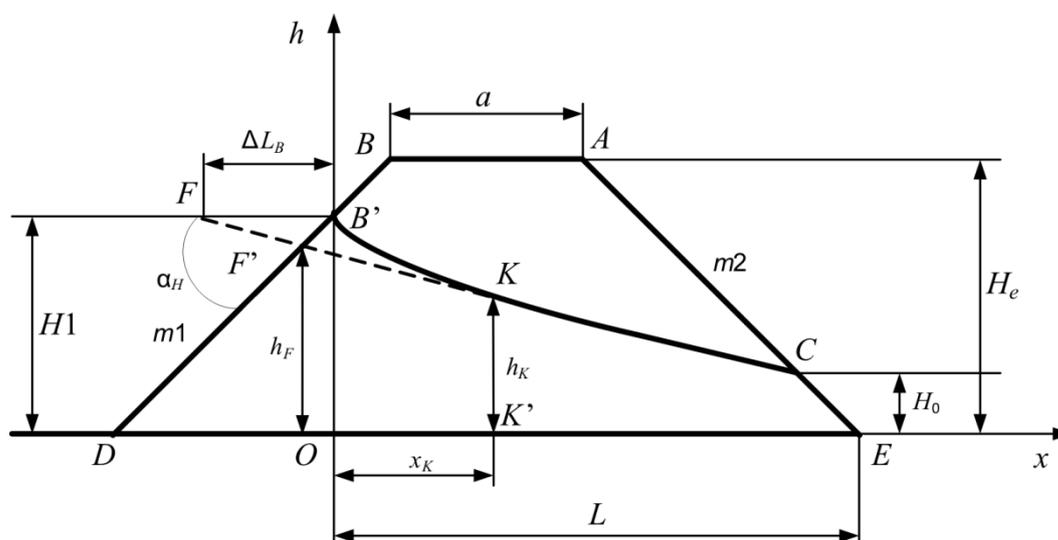
Fig. 4. Scheme for calculating the drawdown curve in the slope  
 Рис. 4. Схема к расчету кривой депрессии в откосе

After constructing the surface of the filtration flow the body of potential landslide is divided into vertical compartments with a width of  $b = 4$  m, in each of which the height of the compartment above is measured ( $h_c$ ) and below ( $h_b$ ) depression curve and sliding surface inclination angles ( $\delta_c$ ) and filtration flow ( $\delta_b$ ) (Fig. 4).
